## Bryston 3Be Power Amplifier repair - Hints and Lessons Learned

\* To share my experience repairing the 3Be's power supply and replacing aging tantalum capacitors.

\* Bryston 3Be stereo amplifier, serial number 330033.

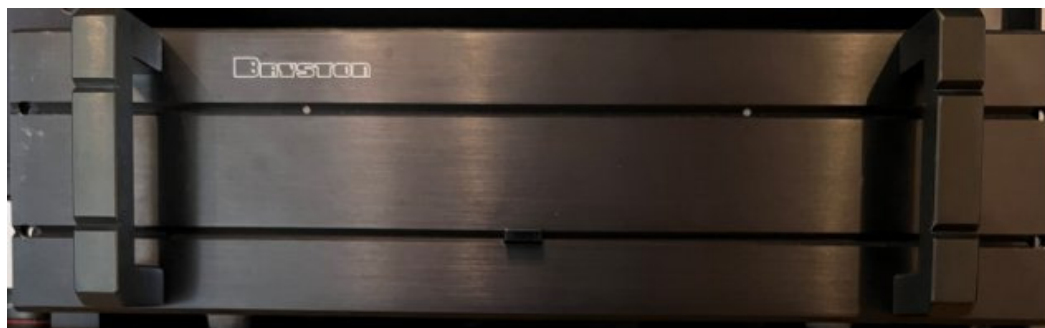
Figure 1: Bryston 3Be front view after repairs - photo taken January 2023

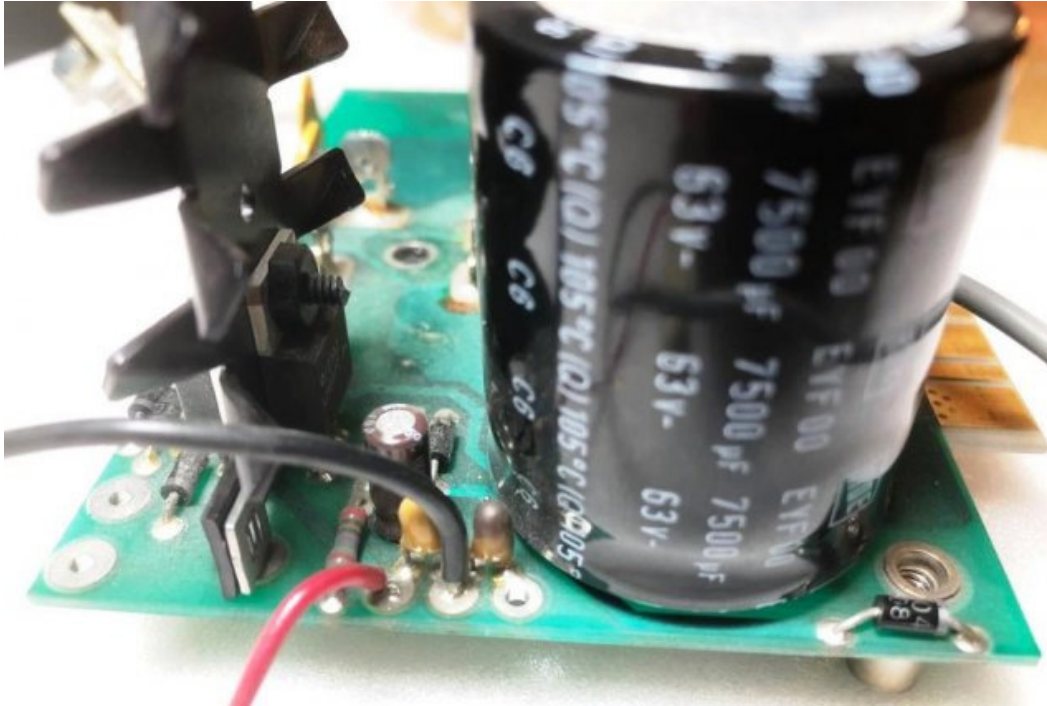
- \* Measured voltage at LM317 Positive Regulator:  $V_{in} = +55 \text{ VDC}$ ,  $V_{out} = +17.7 \text{ VDC}$ . Good.
- \* Measured voltage at LM337 Negative Regulator;  $V_{in} = -55 \text{ VDC}$ ,  $V_{out} = -0.7 \text{ VDC}$ . Not good.
- \* Observed the 1.5uF tantalum capacitor on negative voltage side was burned (Fig. 2).

Figure 2: Tantalum capacitors (Left capacitor normal color, Right capacitor discolored/burnt).

- \* To be aware at all times of safety to equipment and yourself, when powered up both AC line voltage and +/- 55 VDC is present!
- \* Desoldered and removed both tantalum capacitors, replaced with new tantalums having same rating as original, 1.5 uF / 35V (Fig. 3).
- \* Repeated this for the other channel, replacing both tantalum capacitors with new.

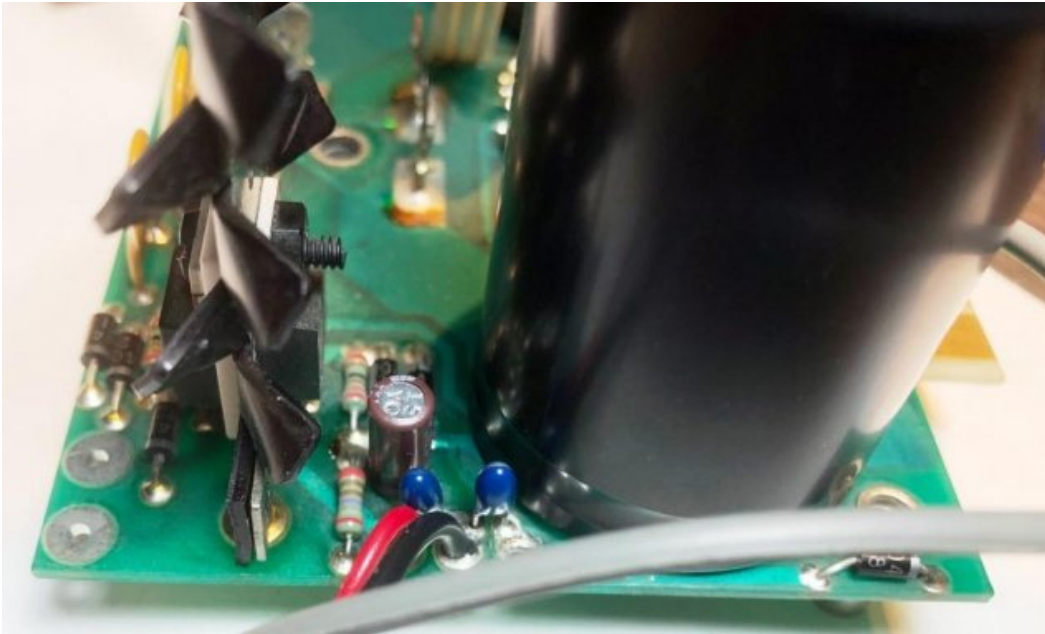
*Figure 3: Replaced both tantalum capacitors (Blue color).*

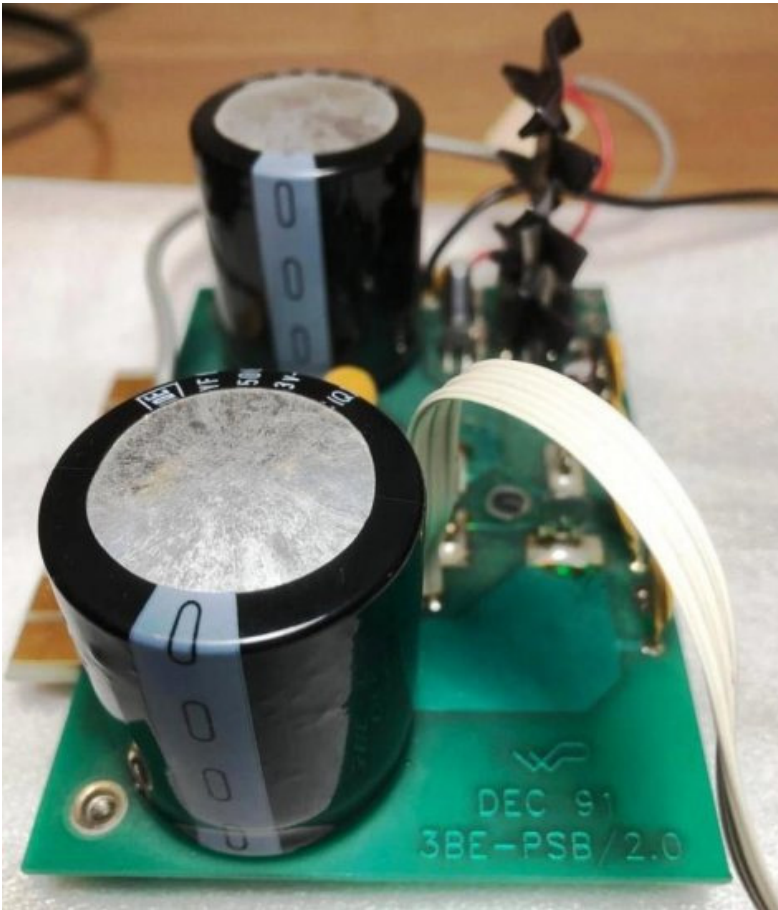
- \* To be honest I didn't find anything else wrong in the power supplies, and although it may not have been necessary, decided to changeout the large power-supply capacitors due to equipment age of 30 years, of which 20 years was in storage.
- \* The original power supply fitted capacitors (qty 4) were made by Roederstien of Germany with rating 7,500 uF, 63 V, 105 Deg C (Fig. 4).

Figure 4. Original dual capacitors fitted to each channel, RDE 7,500  $\mu\text{F}$ , 63 V (note board markings Dec 91, 3BE-PSB/2.0).

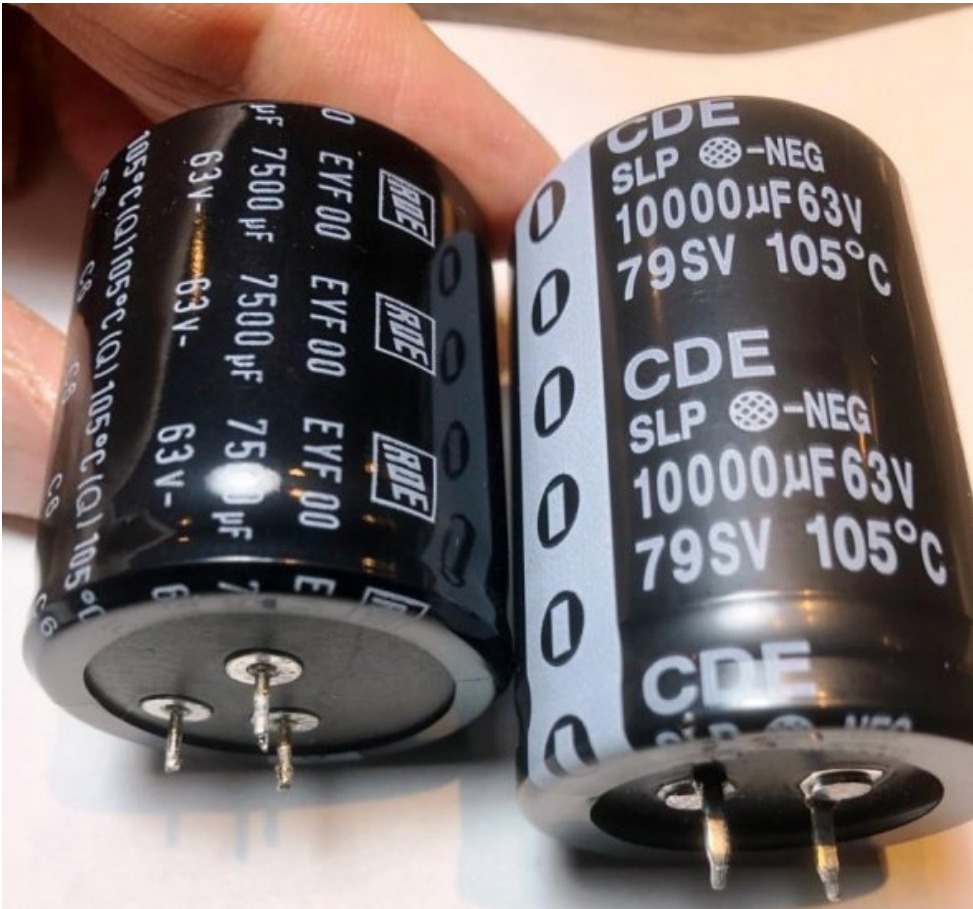
Figure 5. Original RDE with 3 straight leads as fitted (left), replacement CDE having 2 snap-in pins - note larger diameter pins (right).

\* Unable to find Roederstein capacitors of the same electrical rating and mounting type having 3 straight leads, I replaced with new Cornell-Dublier SLP103M063H9P3, having rating 10,000  $\mu\text{F}$ , 63 V, 105 Deg C, knowing that modern electrolytic capacitors typically employ 2 snap-in pins requiring 2 mm dia. PCB holes (Fig 5).

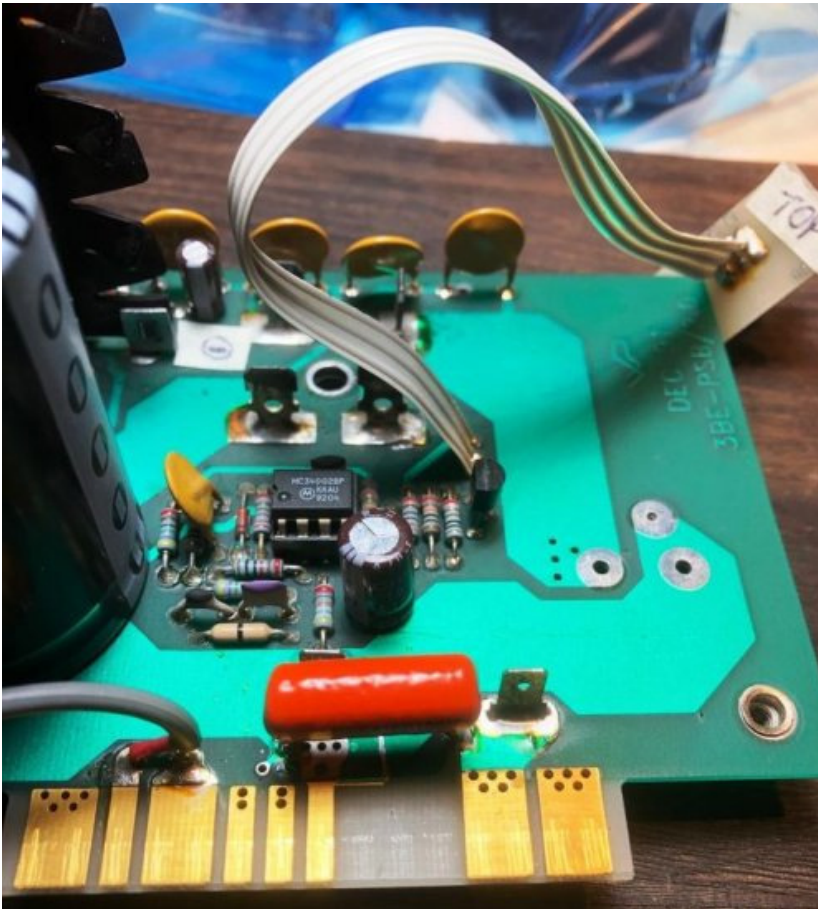
Figure 6. Two PCB holes drilled out to 2mm (the third hole is now redundant and does not need to be enlarged).

\* After desoldering and removing the two RDE capacitors, carefully enlarged the positive and negative mounting holes using a fresh 2mm drill bit (Fig 6). The third hole becomes redundant and was left as is.

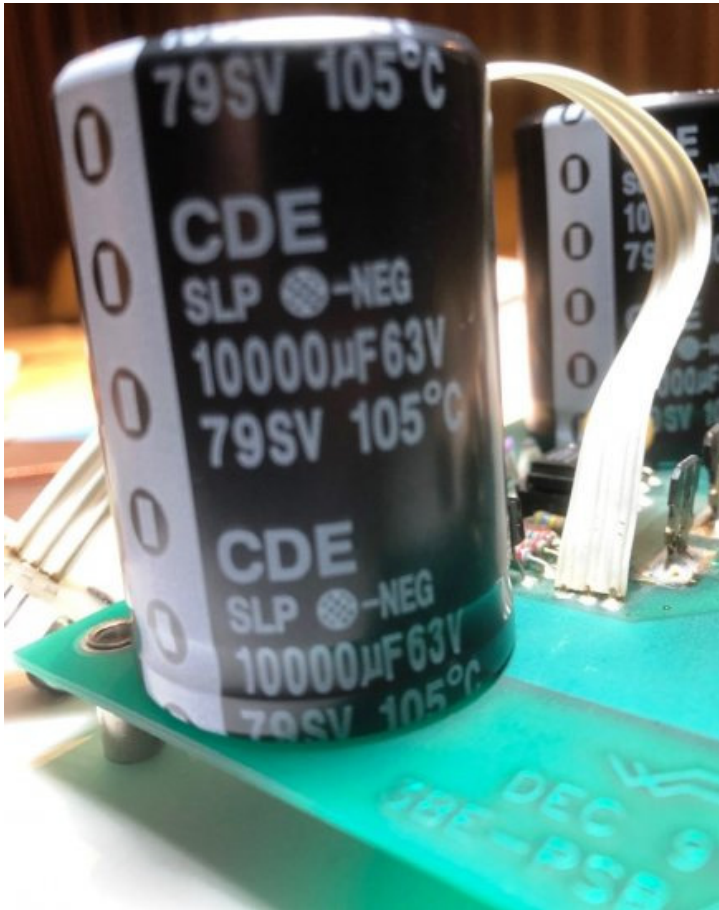
*Figure 7. Replacement capacitor mounted.*

\* With this modification the new capacitors fit nicely (Fig 7). Ensure to double check all polarities are correct before soldering the snap-in pins in place.

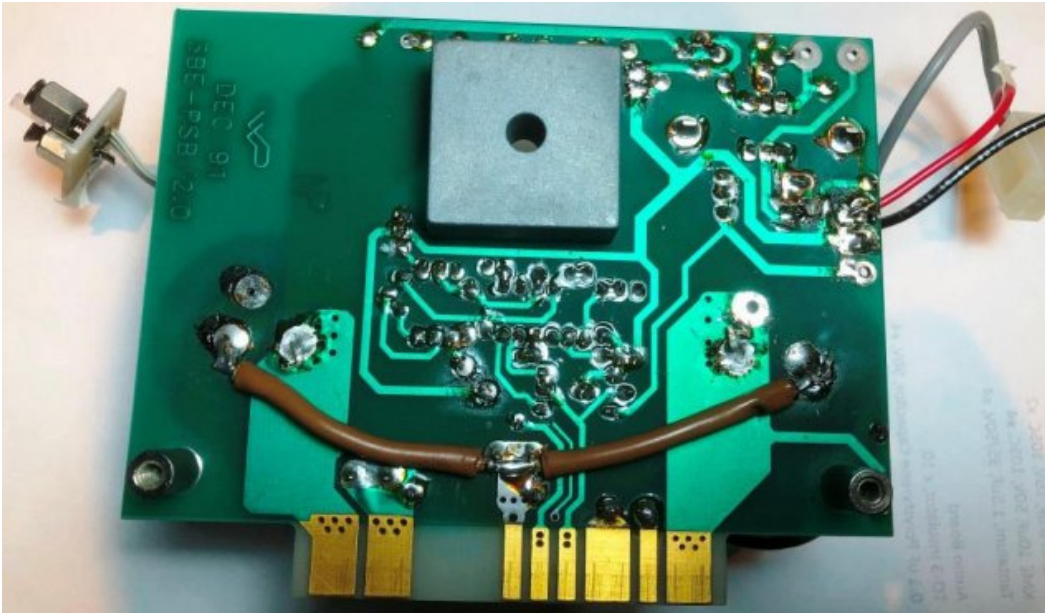
- \* While this makes for a neat and tidy mechanical mounting of a modern electrolytic capacitor replacement, a consequence of enlarging the mounting holes to the standard 2mm dia. is the loss of thru-hole conductance, resulting in loss of electrical connection on one side of the capacitor.
- \* One way to restore this connection is to run a jumper wire connecting the 2 outer pins of each capacitor back to the common ground (Fig 8). This is not to make any changes to the circuit, just to restore the connections originally made by the PCB traces.
- \* Although this was not my best soldering effort as it was meant to be a trial to confirm the jumper wire installation worked, it did work and has been working well without issue ever since.

Figure 8. Installation of jumper wire on the underside of the power supply PCB.

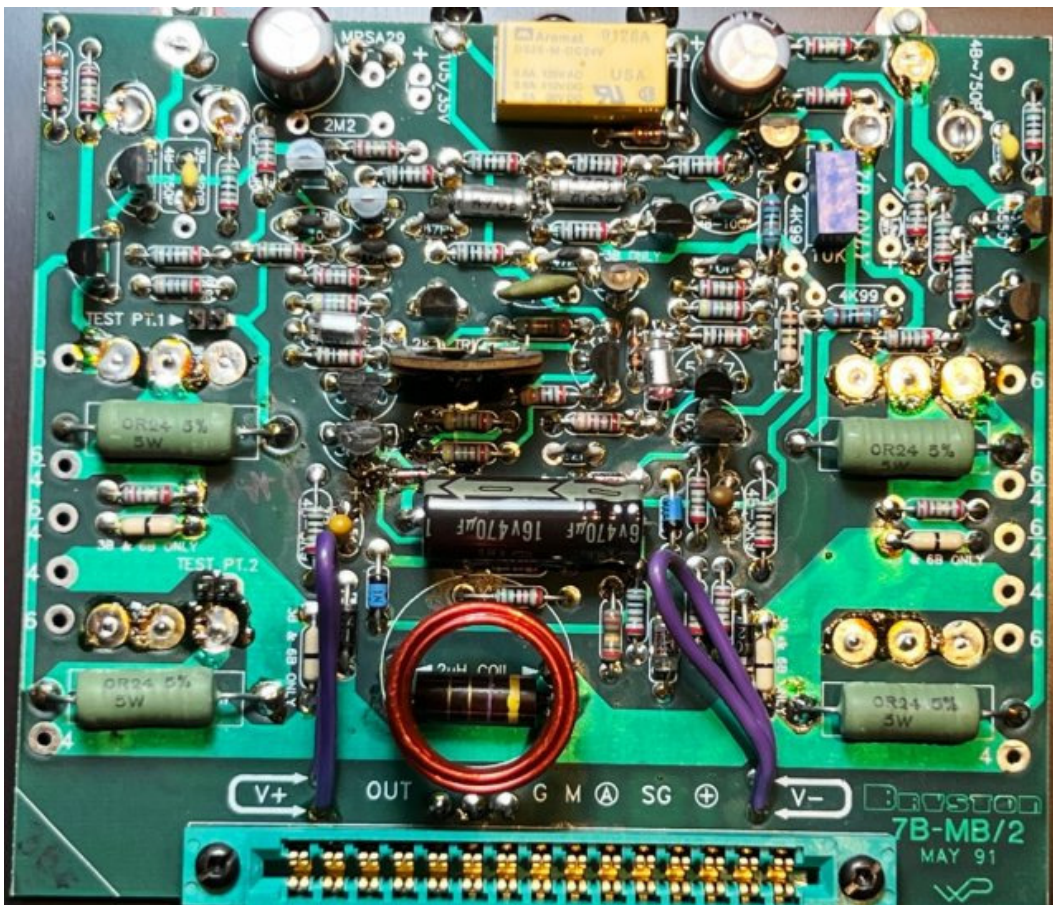
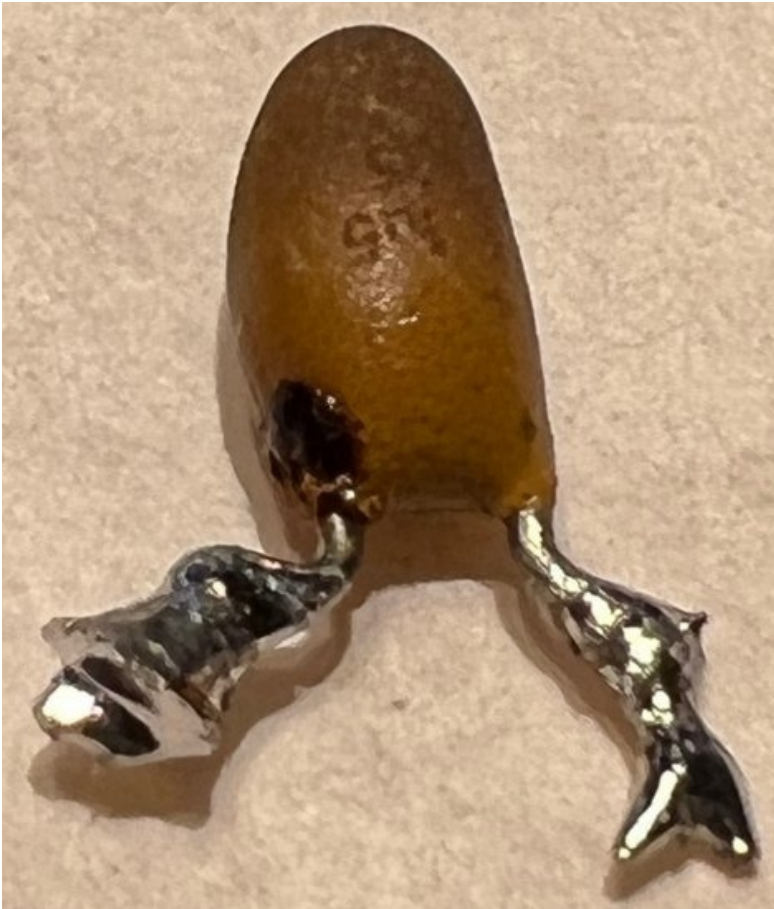
- \* After repairing the power supply the amplifier worked reliably, then after some 4-months of operation suddenly one audio channel went dead.
- \* Found the 33V Zener diode voltages supplying the input differential pairs was unstable. Problem traced to the 1.5 uF / 35V tantalum capacitors paralleled across the Zener diodes had become discolored and were leaking (Fig 9).

*Figure 9. Two tantalum capacitors on either side of the black axial capacitor, closeup of a removed tantalum burnt/leaking.*

- \* Interesting to note, after 30-years all 8 tantalum capacitors (4 in the power supplies, 4 in the audio boards) had to be replaced, whereas all other components remain fully operational. Possibly the original series of tantalum capacitors may have been from a weak batch.

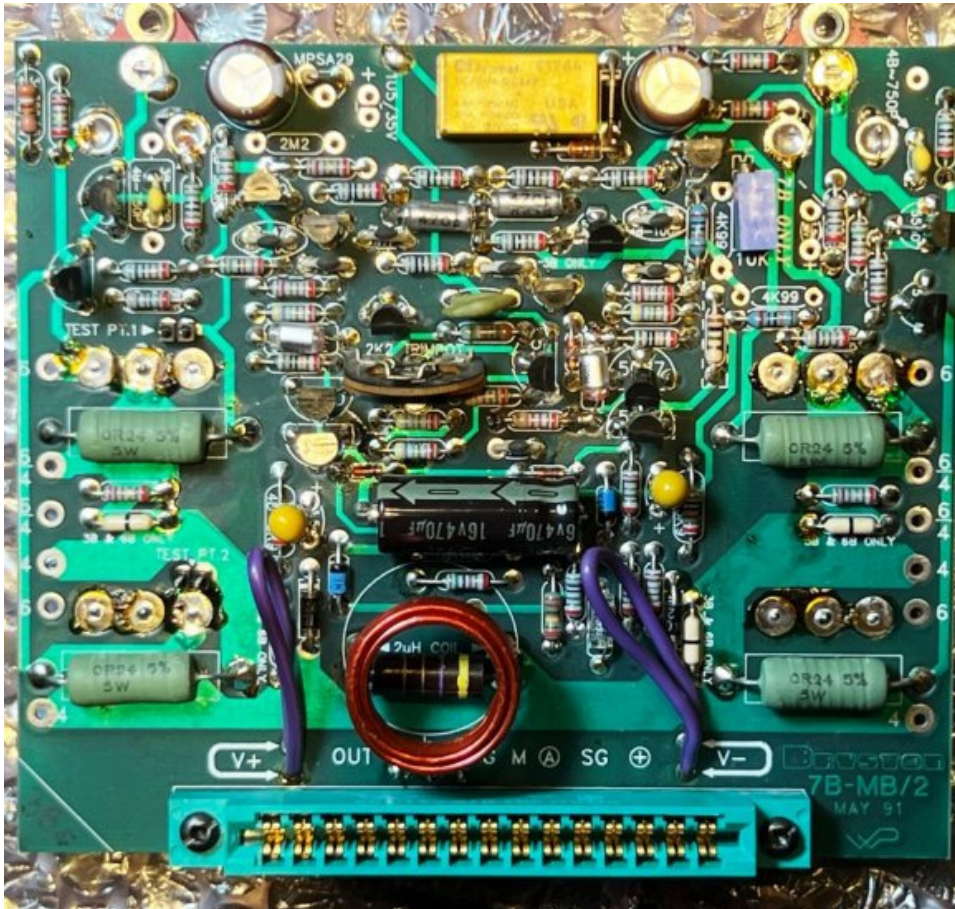
Figure 10. Two new tantalum capacitors installed on audio board (installation repeated for other board).

\* Although my local supplier had 1.5  $\mu\text{F}$  / 35V tantalum capacitors in stock, to install a 35V rated component in a 33V operation I felt was borderline so purchased instead higher rated 2.2  $\mu\text{F}$  / 50V tantalum capacitors (my local supplier had sold out of 1.5  $\mu\text{F}$  / 50V rated tantalums). Although these new capacitors were slightly larger in size it was straightforward to install them on the audio board (Fig 10).
