Date	Ref. No.	Model	
22.01.10	10TV004	EX-2L_Basil_Sat, EX-2L_Coriander_Sat, EX-2L_Paprika_Sat Chassis	BC
Subject			IRIS
Software Recovery Tool for BA Board			111A

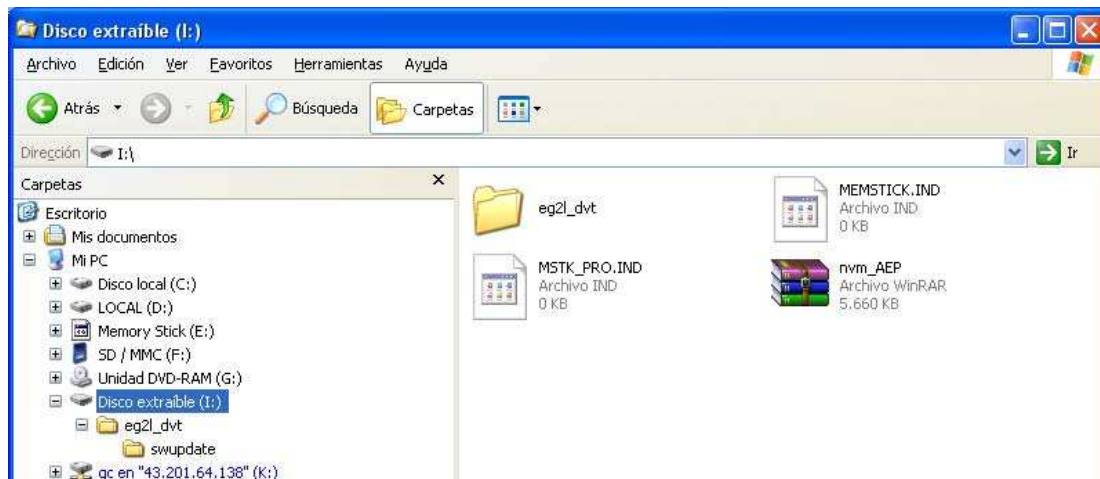
2-4. Copy the TAR file into root directory of the Memory Stick. The MS root folder should look as below (Make sure that ‘Show hidden files and folders’ is activated in the Explorer Options).

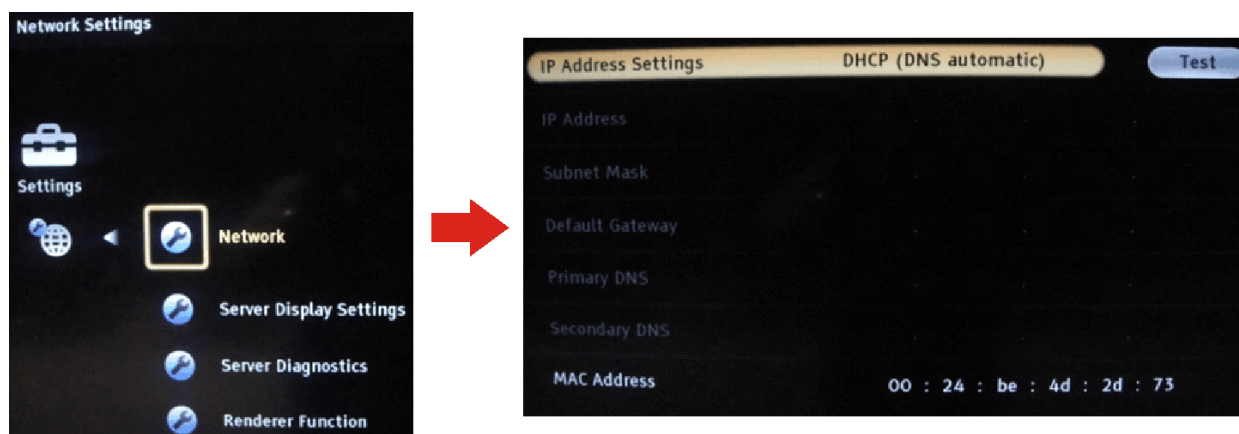
2-11. Check the MAC Address value in Menu => Settings => Network settings => Network.

NOTE: If the MAC address is empty (6 times “00”), this board cannot be used and must be returned for central repair.
