This article discusses protection topics related to a valve amplifier's output transformer.

Over-current and over-voltage stresses are common causes of output transformer failure, so these two topics are discussed in detail. The influences that can cause stress are described, along with common techniques for managing those stresses. Fuse and PTC selection for over-current is discussed. MOV selection for output transformer over-voltage protection is presented as a simple addition.

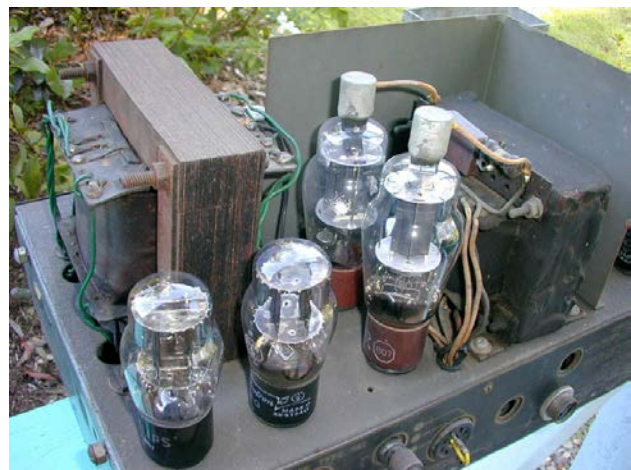
Like all parts, adequate cooling is required for the OT. Some amplifiers have a very poor layout of transformers and valves, with parts sandwiched together in close proximity, and with marginal ability for free air movement to allow removal of heat. This situation is compounded in some old amplifiers that were intended for PA use, where output power was often only intermittently needed, or the amp was not often loaded to a maximum level. A restoration can also mean an amplifier used nowadays for guitar or bass could have a much higher continuous output loading than originally intended, and be often cranked into over-drive.

OT sandwiched between output valves and barriers.

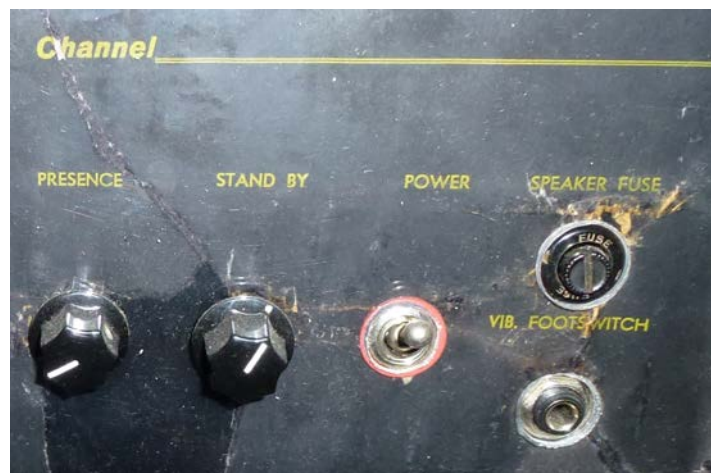
Speaker fusing is not common – with good reason!

Figure 5. Some practical examples.

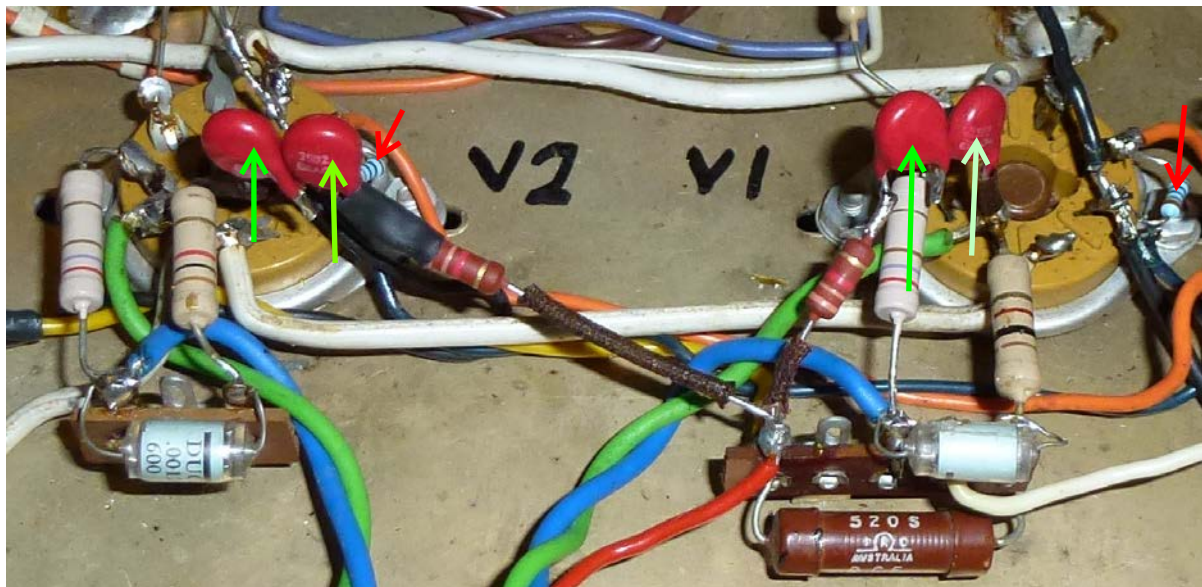
Figure 9. Ultra-linear PP stage (RTV&H 1960 100W PA amp). Original RC network from plate to screen. 1 $\Omega$  cathode sense resistors added. Series MOV-R circuit added to each primary half. No screen stoppers added.

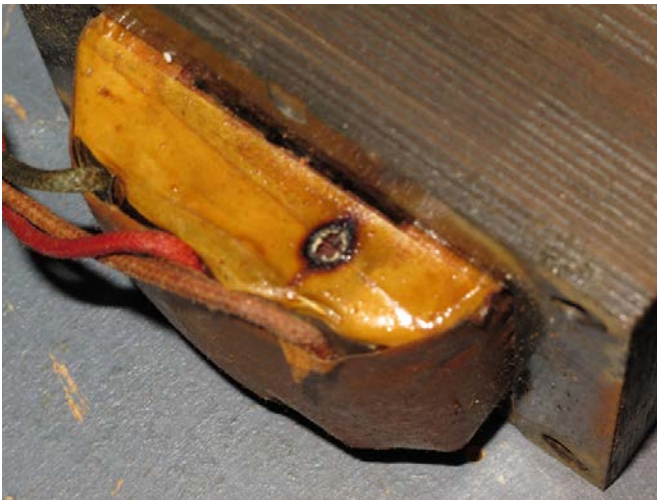
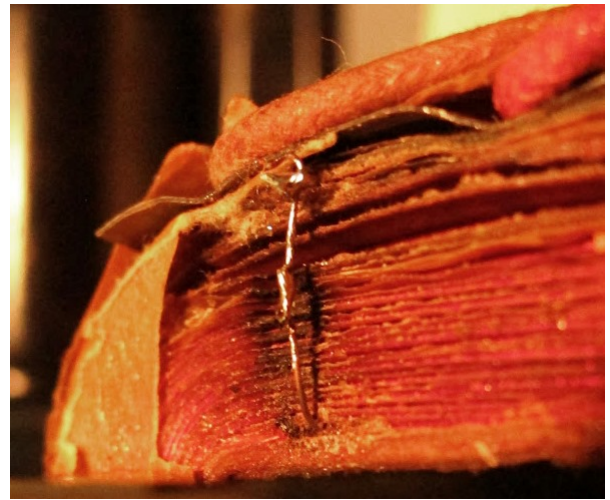
Figure 11. Repairable fault in output transformer.

Figure 11 shows a repairable fault in an OT. Arcing from half-primary winding layer edge turns to the other half-winding plate link wire had caused an obvious area of over-heating damage that resulted in an open-circuit. The OT was repaired by replacing the link wire, and carefully insulating it (not shown). [[Hoffman Amplifiers Forum](#) but thread now lost]
